# Manhole Inspection Summary

Manhole # S37C\_\_016MH

Insp Date: **8/22/08 2:54 PM**

**Location** Address: **312 n high st**

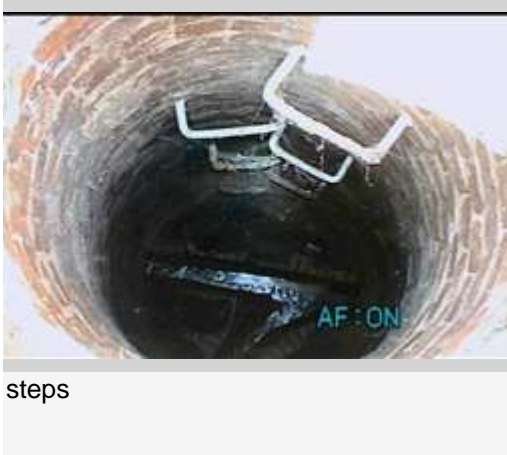
Defect 2

Count: **6** Missing: **0** ☒ **Corroded**

steps

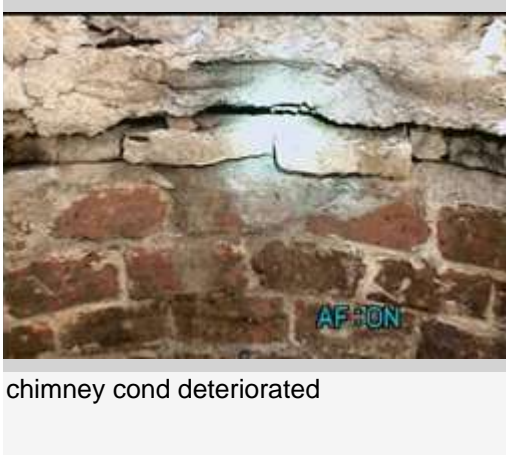
Defect 1

Condition: ☐ Sound ☐ Cracked ☐ Root Intrusion ☐ Loose Brick ☒ **Deteriorated**

chimney cond deteriorated

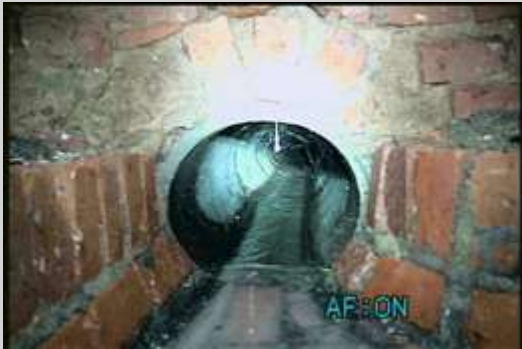
12 O'Clock Outflow

10 in. Circular Gravity Sewer  
Pipe Out @ 12 O'Clock

Infiltration: **None** Pipe Seal Cond: **Unknown**

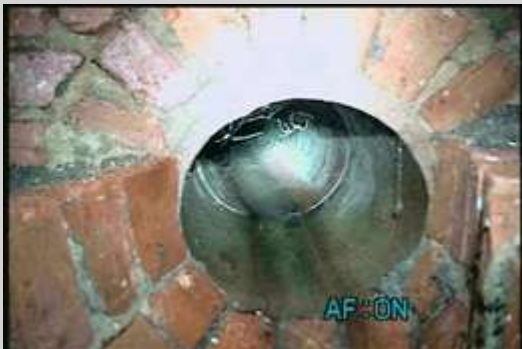
3 O'Clock Inflow

8 in. Circular Gravity Sewer  
Pipe In @ 3 O'Clock

Infiltration: **None** Pipe Seal Cond: **Unknown**

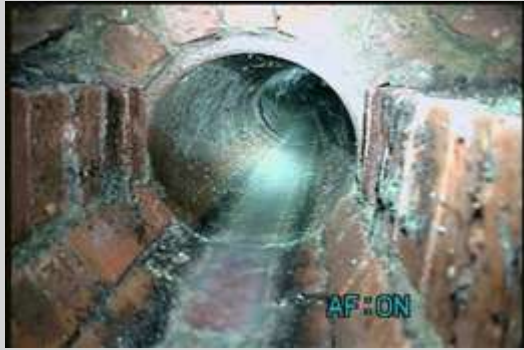
6 O'Clock Inflow

8 in. Circular Gravity Sewer  
Pipe In @ 6 O'Clock

Infiltration: **None** Pipe Seal Cond: **Unknown**
